# TRENCHING IN ROUGH SEAS

**John Lincoln, OES, USA, discusses the challenges faced during a subsea pipeline trenching project offshore Ghana.**

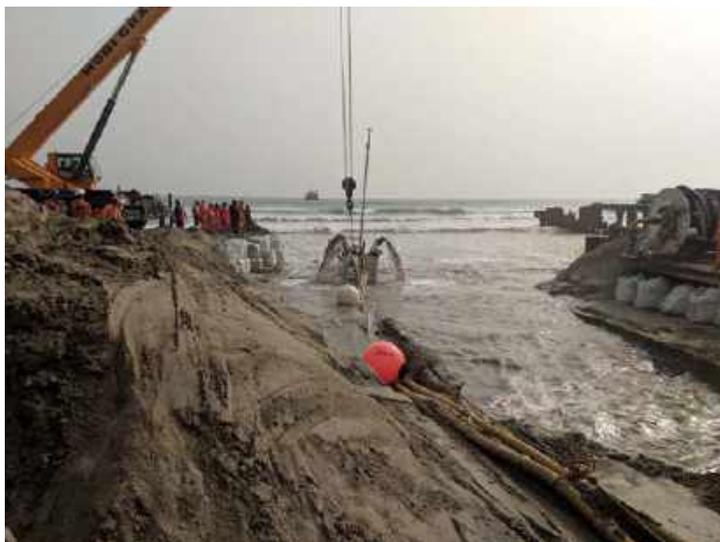
Figure 1. Completed pre-trenching, and the start of post-trenching.

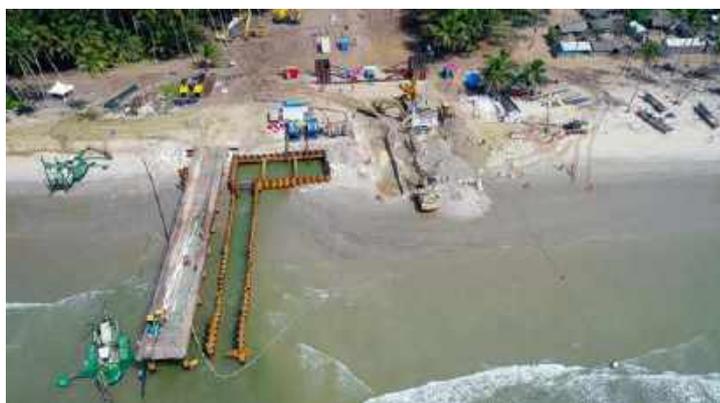
Figure 2. The layout on the beach for the onshore operation, including the failed shallow water spread to the left.

The seas off the African coast in Ghana are rough and the water very shallow, creating a wave-breaking zone that extends 300 m out from the shore. It was difficult to find a suitable barge, and the process involved considerable creative thought from Micoperi, Subsea, ENI and OES. ENI, in the meantime, attempted to use a shallow water spread, but to no avail.

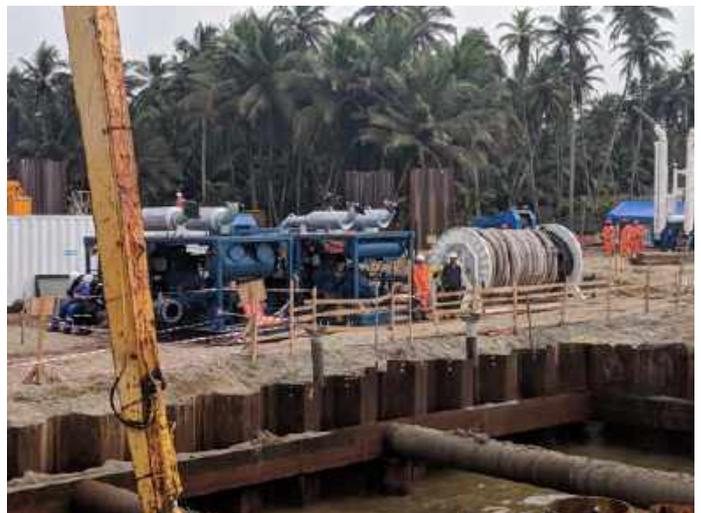
Figure 3. Pumps at the edge of the suction pit.

The trenching work began on-site in mid-December 2018. The operation went to plan; however, there was a large amount of debris that entered the pit and plugged up the pump suction strainers, so the suction pipes had to be removed daily and the suction strainers cleaned. In addition, it was difficult at times to deploy the machine with the crane, as the crane could not get out far near the water.

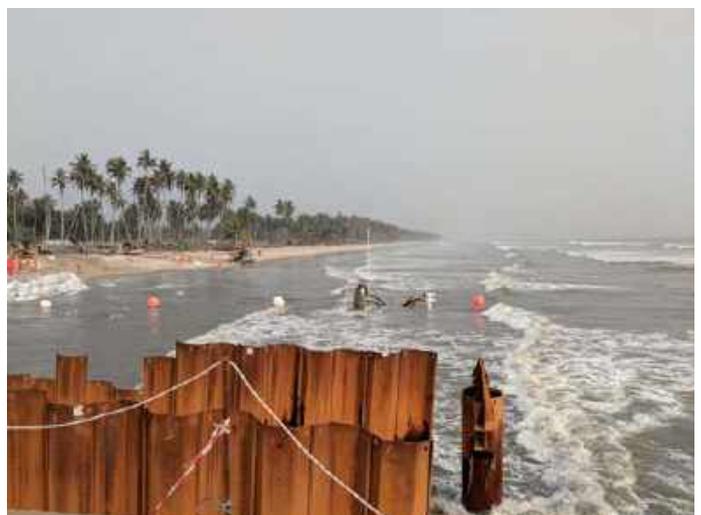
Figure 4. A side view of the suction pit (foreground).

Micoperi provided critical design input, as the soils were dense compacted sands and percolation from underneath was not considered reliable. As a result, the company embarked on building a feed pipeline to the pit from approximately 50 m offshore, and found it also had to support this with a piled structure. A
